PHASE I INSPECTION REPORT
NATIONAL DAM SAFETY PROGRAM

JORDAN DAM
WILSALL, MONTANA
PARK COUNTY
MT 334

HKM ASSOCIATES
BILLINGS, MONTANA

APRIL 1981

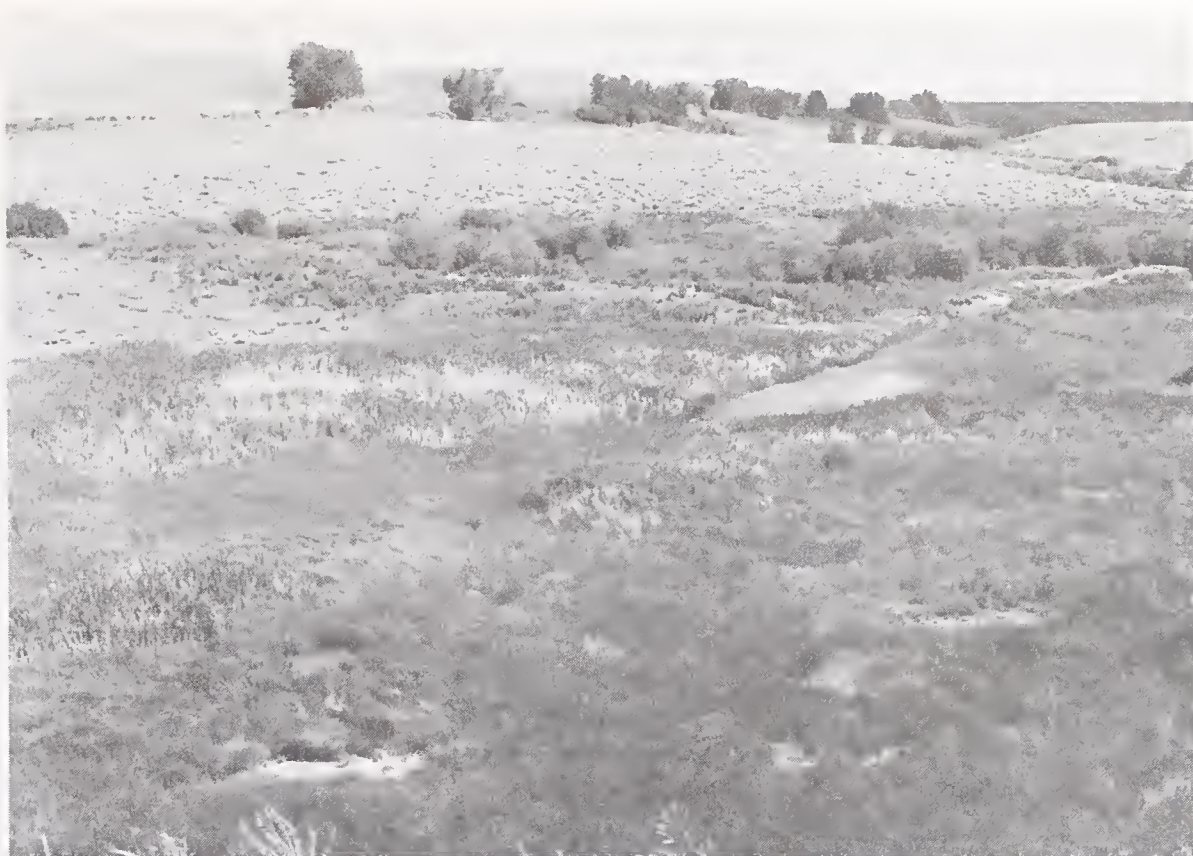
Photo No. 9 - Old Dike.

There is an old earthen dike located approximately 100 yards downstream of the dam embankment (Photo 9 of Appendix B). This dike suggests that an old reservoir may have been located immediately downstream of the existing embankment or that the Jordan Dam may be located in the pool area of an older reservoir. The impact of this old reservoir on the design and construction of Jordan Dam is unknown. It is also possible that this dike was constructed as a retaining dike on the right side of Antelope Creek.

An old earthen dike is located approximately 100 yards downstream of the dam embankment.
